Appendix D- Interactive Reach Prioritization Tool Methods Development

Interactive Reach Prioritization Tool Methods Development

PREPARED BY: Anthony Falzone and Anna Constantino, FlowWest

DATE: 8/24/2017

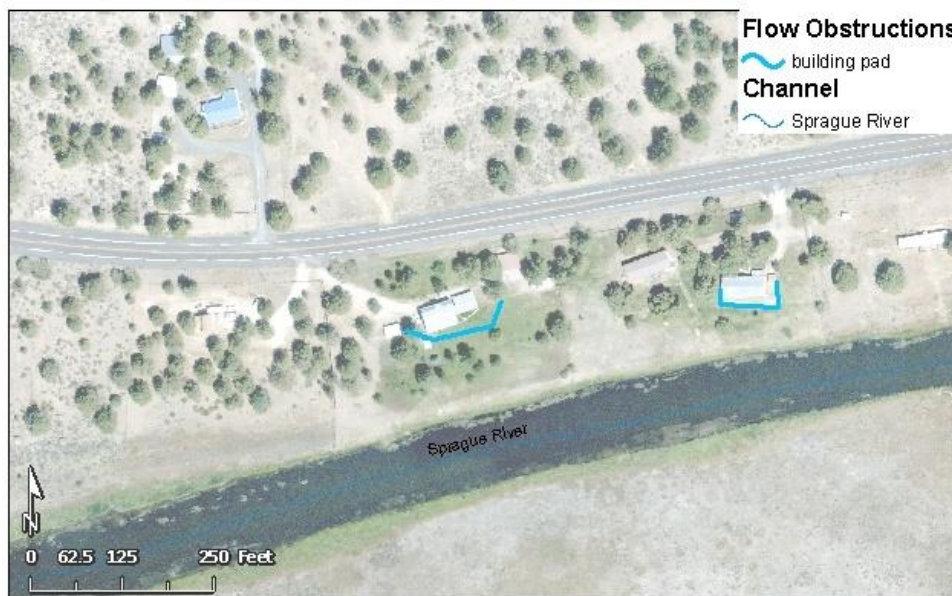
FIGURE 7: EXAMPLE OF BUILDING PAD FEATURES DELINEATED ALONG THE SPRAGUE RIVER.

The development classification includes modified bank or floodplain topography related to residential, agricultural, and/or commercial land use. We identified grading areas where fill has been placed on the floodplain and building pads where structures have been built in the floodplain (Figure 7).

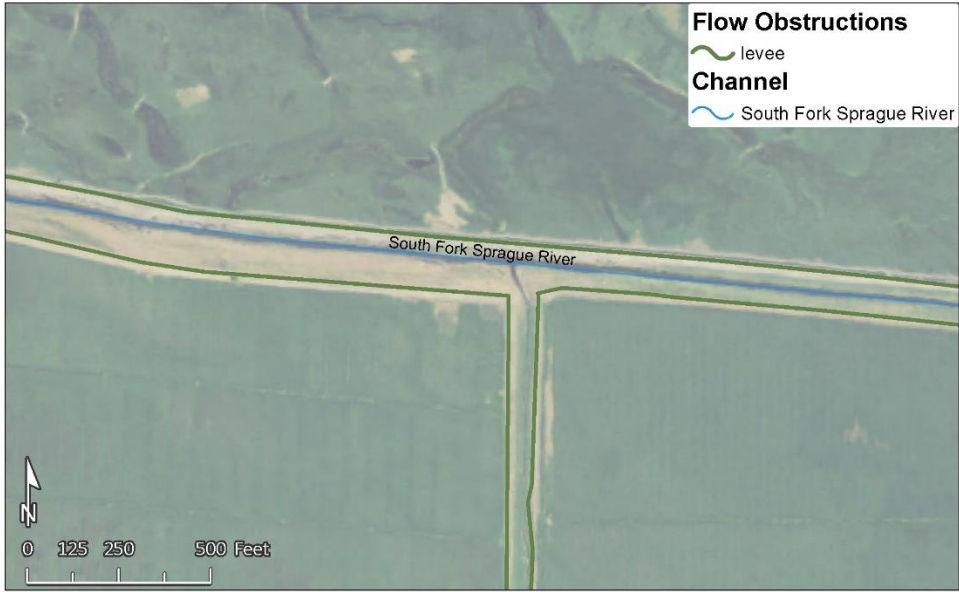
FIGURE 9: EXAMPLE OF THE LEVEE FEATURES DELINEATED ALONG THE SOUTH FORK SPRAGUE RIVER.

For this analysis we defined levees as artificial embankments two feet higher than the surrounding surface along a stream to protect land from flooding or to direct flood flows (Figure 9). Levees often have an adjacent canal or ditch, and in the case of numerous flow obstructions we mapped the dominate feature (based on height or proximity to the channel). Natural levees are geomorphic features found on floodplains and are formed when flood waters spread out onto the floodplain and overbank flows deposit sediment at the top of the bank. We used the two-foot height threshold based on the 2004 lidar data to differentiate artificial levees from berms, natural levees, and natural topographic features. Levee features were characterized as parallel, offset, or perpendicular. A parallel levee follows the top of bank of the channel, an offset levee is set back from the top of bank and typically confines the river corridor from meander bend to meander bend. Lastly, perpendicular levees concentrate floodplain flows into the channel and extend from the top of bank across the floodplain. We define the front of the levee as the side facing floodwaters (typically towards the channel or facing upstream for floodplain levees perpendicular to the channel).

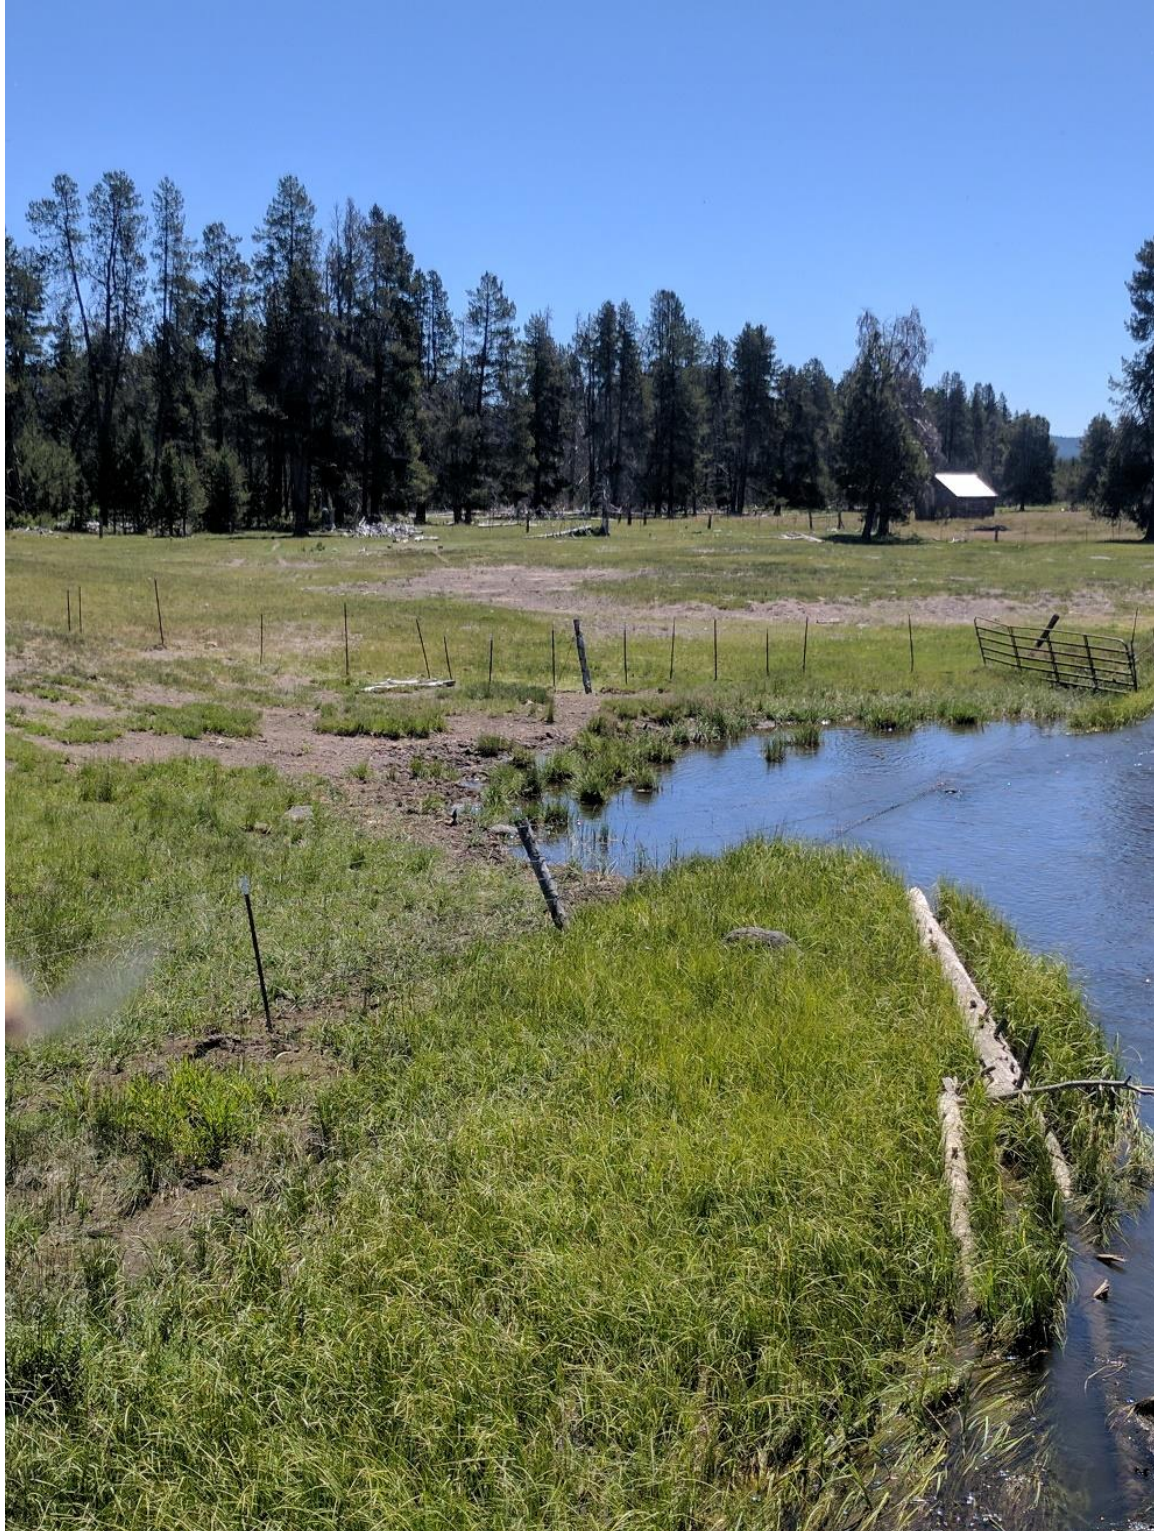
FIGURE 13: UPSTREAM OF BRIDGE ON THE UPPER WILLIAMSON RIVER. NOTE FENCING ADJACENT TO CHANNEL EDGE AND THE ACCESSIBILITY OF THE RIPARIAN AREA FOR CATTLE.

The following series of figures highlights several findings from the June 2017 fieldwork. Figures 13 and 14, 15 through 18, and 19 through 21 refer to the Williamson River, Sprague River, and Spring Creek, respectively.

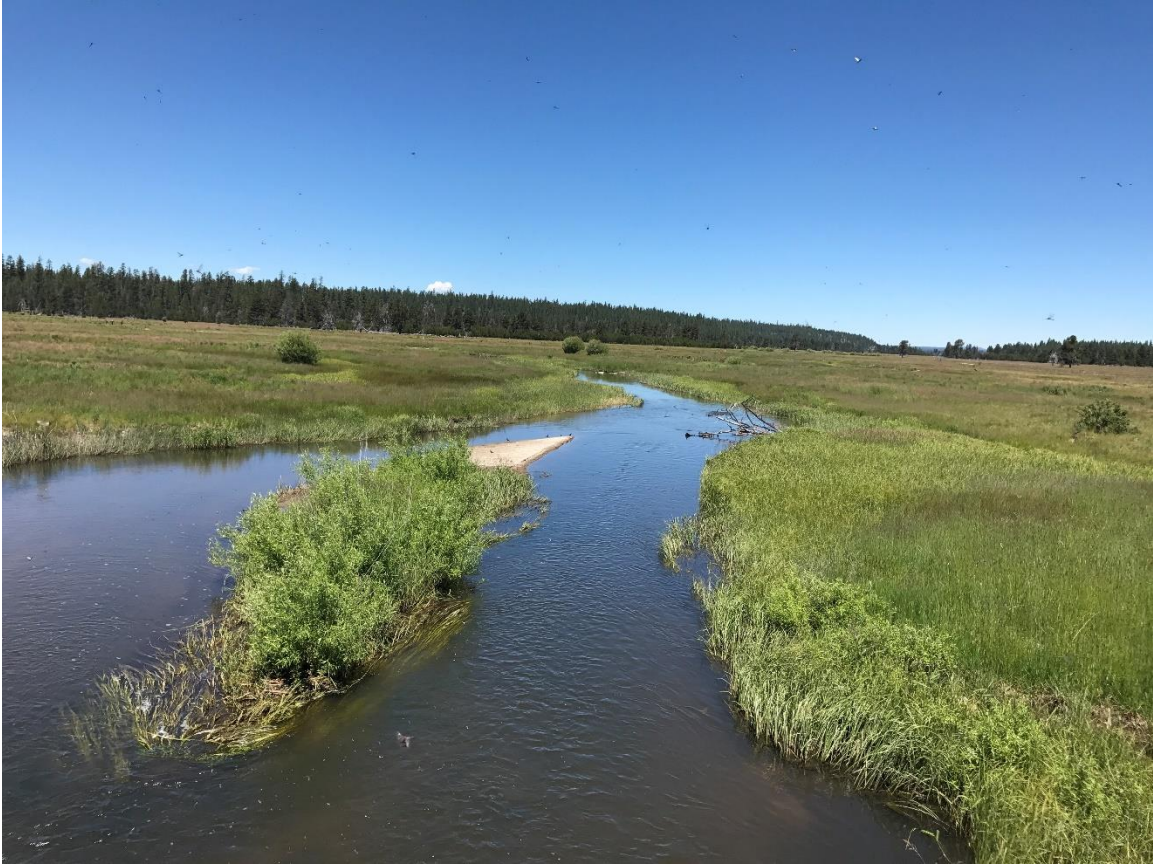
FIGURE 14: DOWNSTREAM OF BRIDGE ON THE UPPER WILLIAMSON RIVER. NOTE RIPARIAN AREA IS FENCED OFF.

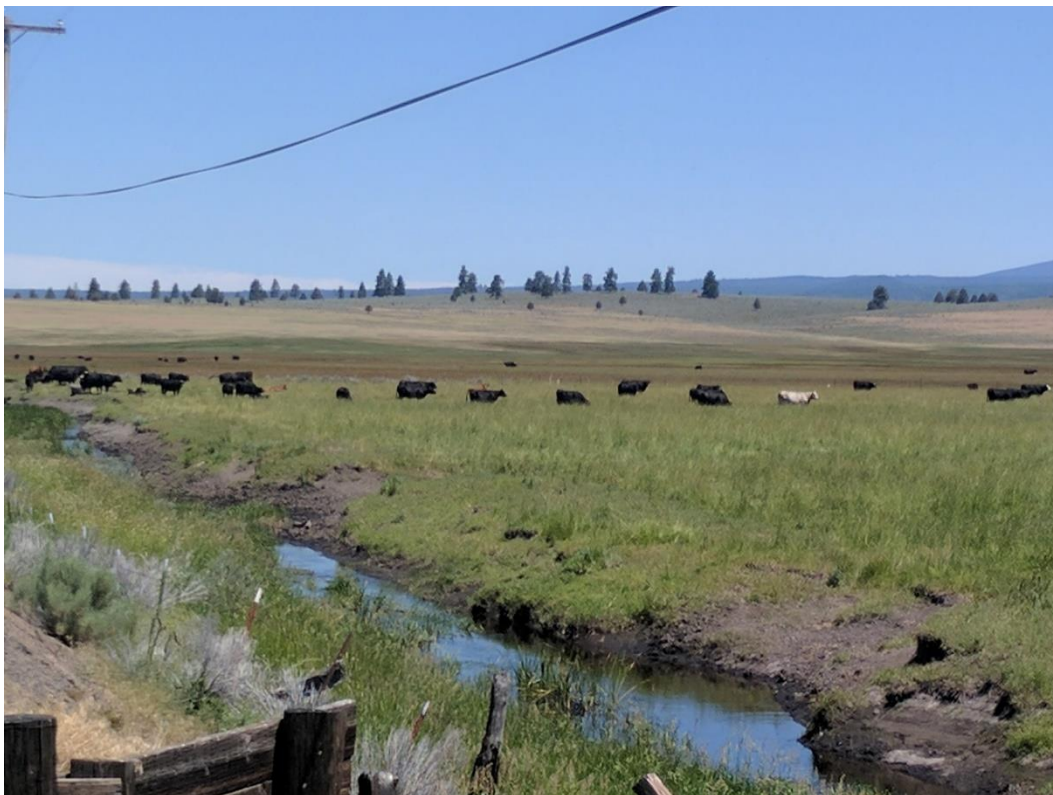
FIGURE 16: CATTLE NEAR IRRIGATION RETURN CANAL ADJACENT TO IVORY PINE ROAD.

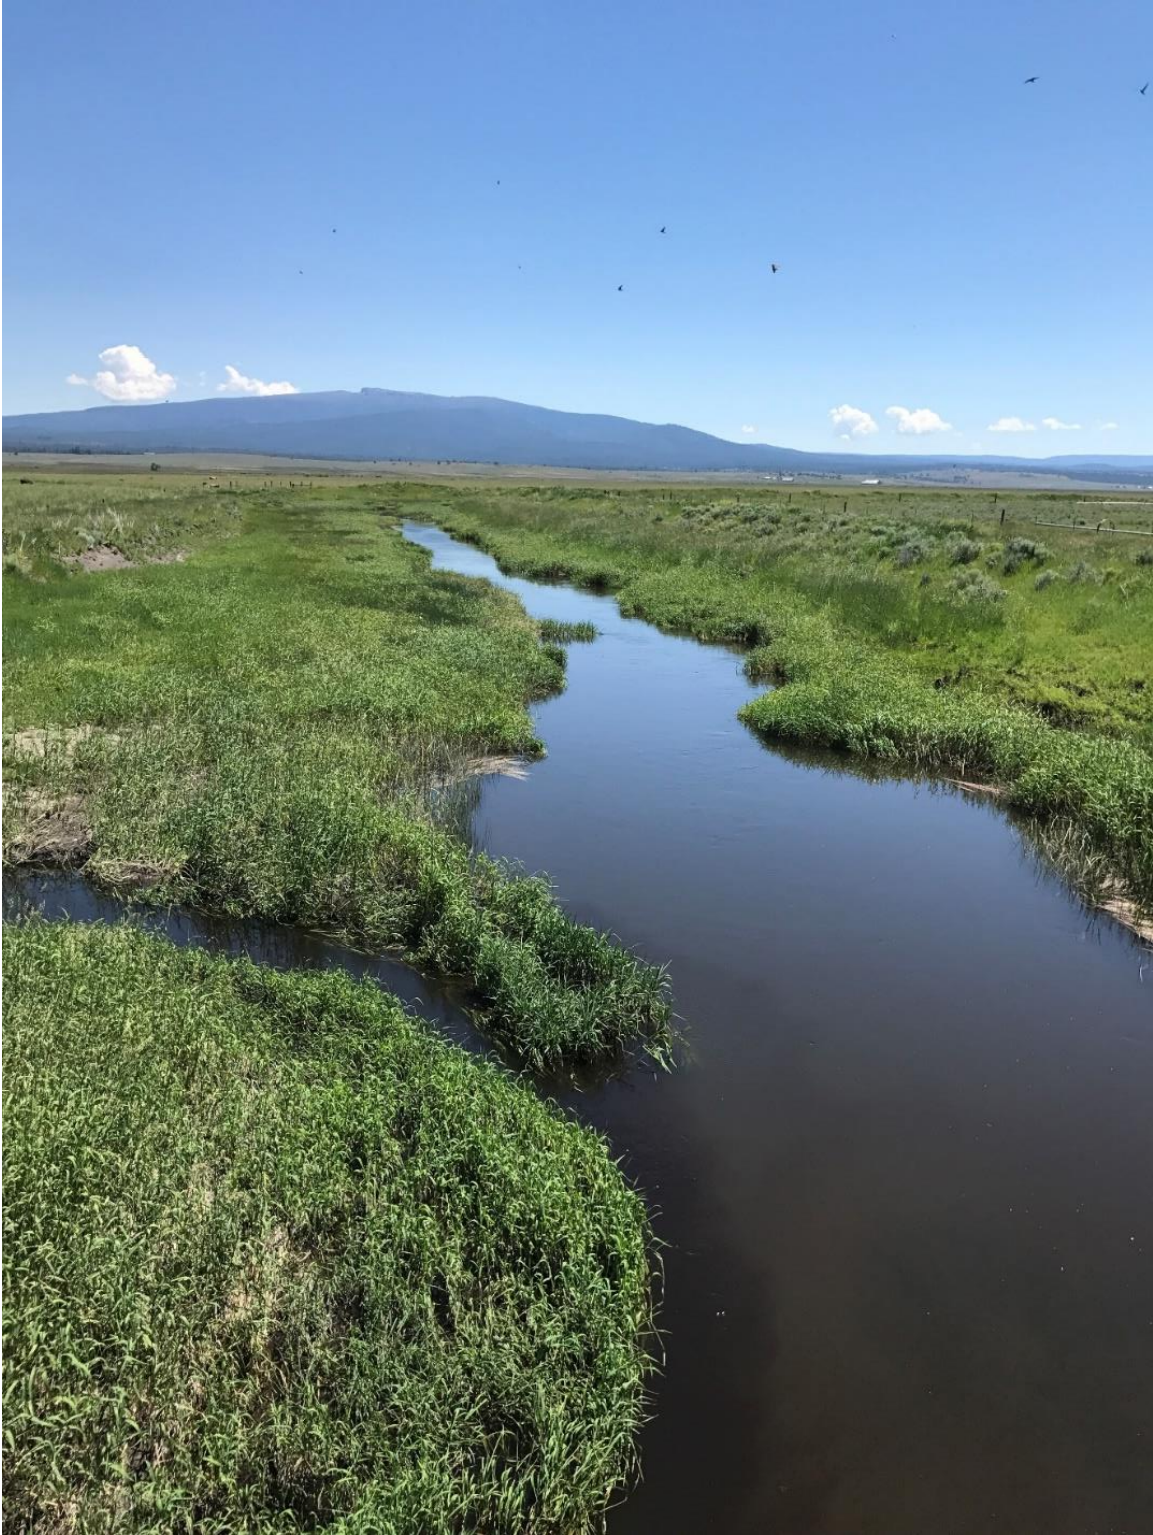
FIGURE 17: RETURN FROM CATTLE AREA INTO SPRAGUE RIVER JUST UPSTREAM OF IVORY PINE ROAD BRIDGE.

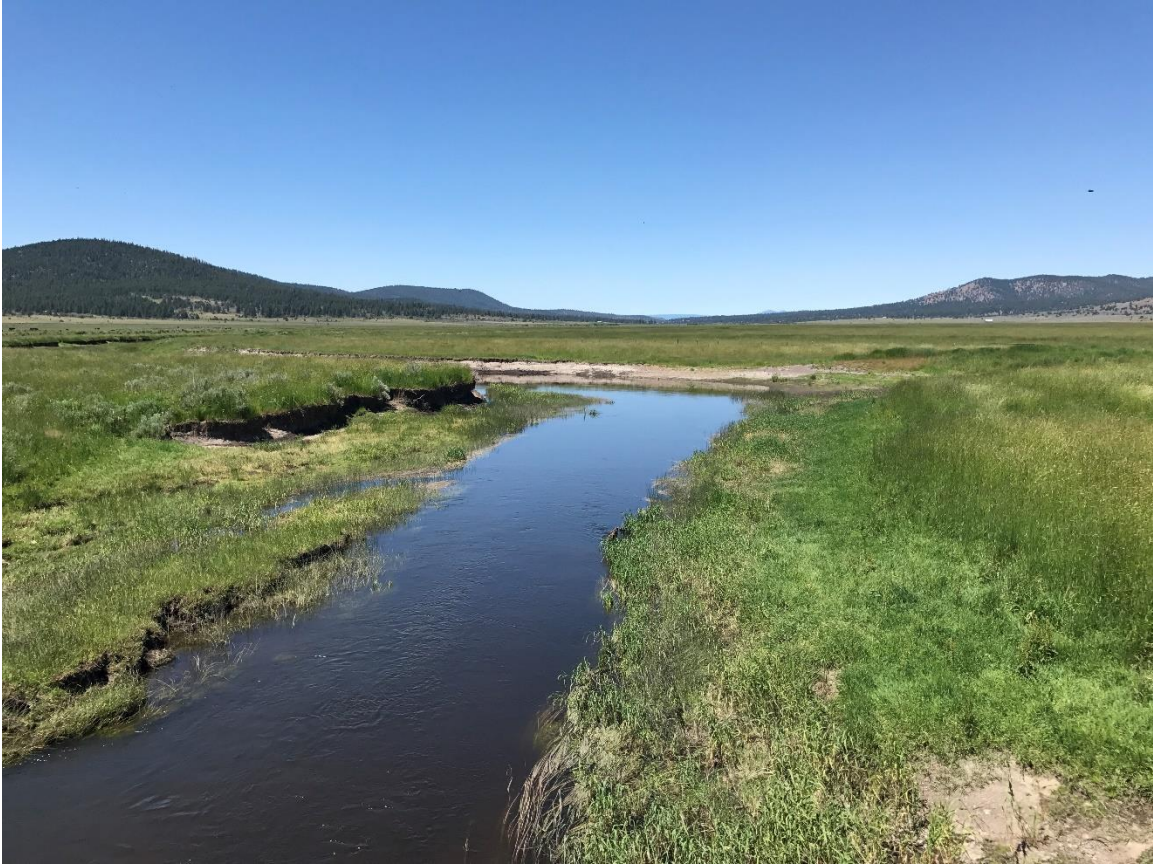
FIGURE 18: RETURN AGRICULTURAL FLOW MIXED INTO RIVER DOWNSTREAM OF IVORY PINE ROAD BRIDGE.

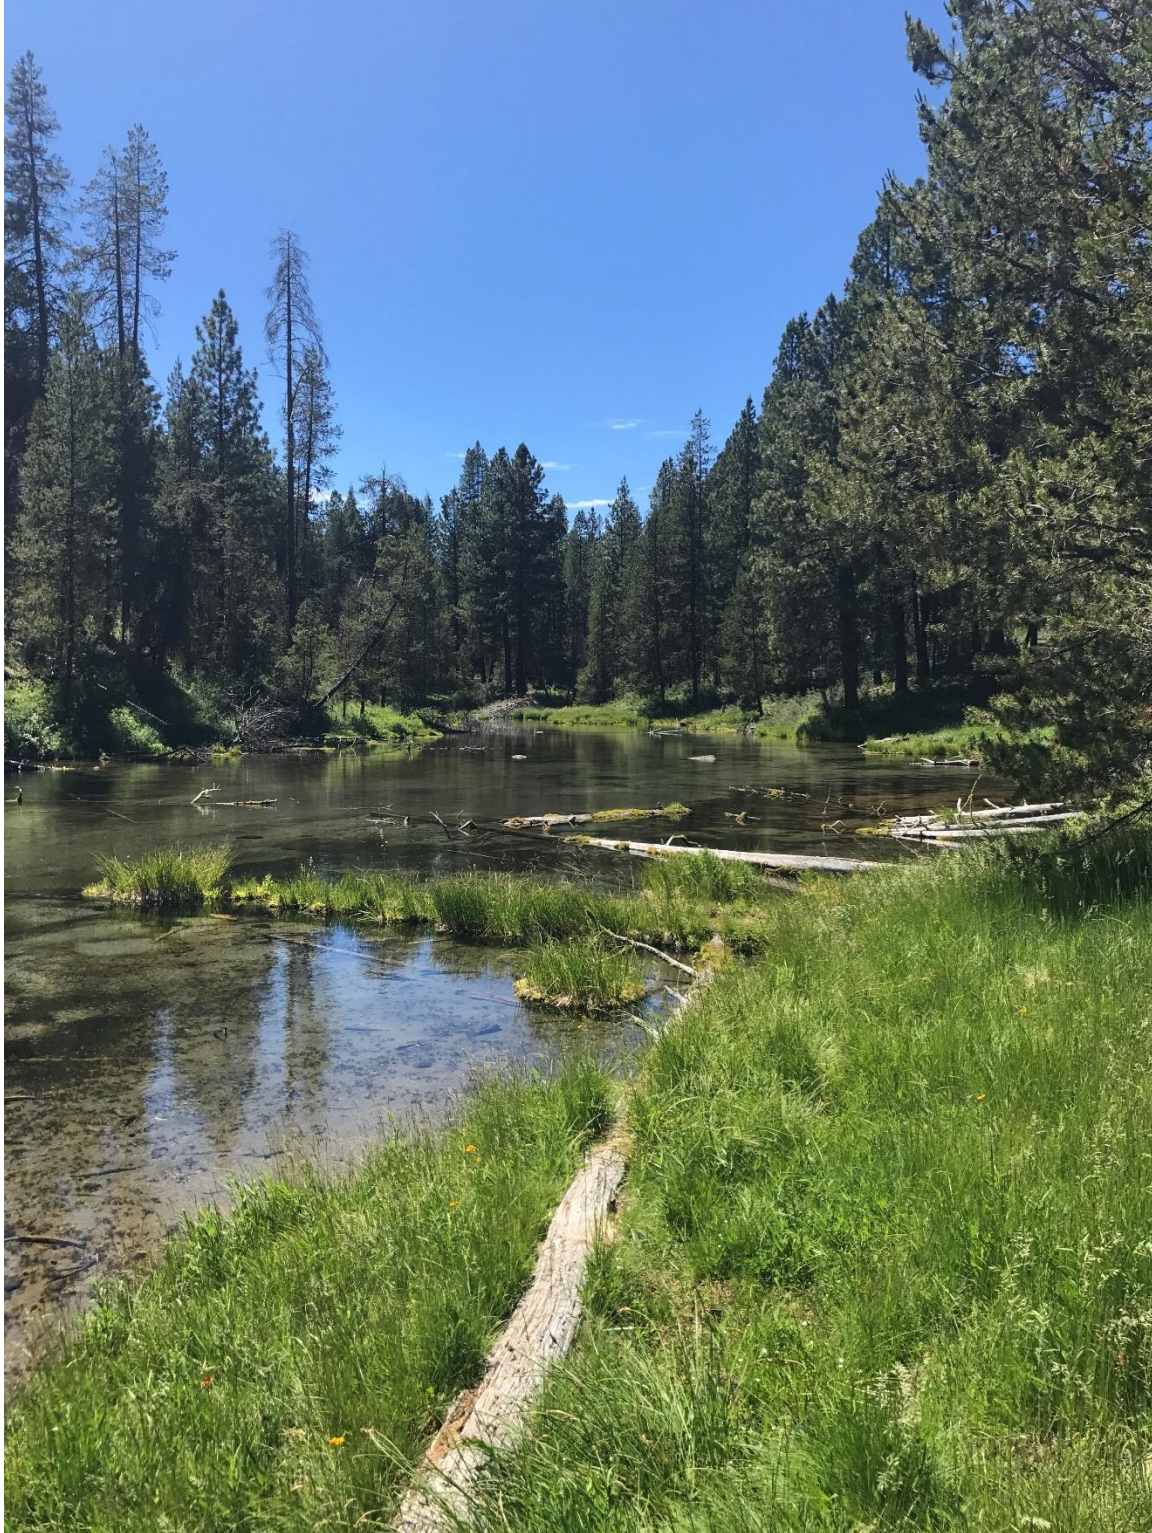
FIGURE 20: SPRING CREEK (LOOKING UPSTREAM) AT LOCATION WHERE A SMALL DIRT ROAD WAS MISIDENTIFIED AS A CANAL FROM ELEVATION DATA.

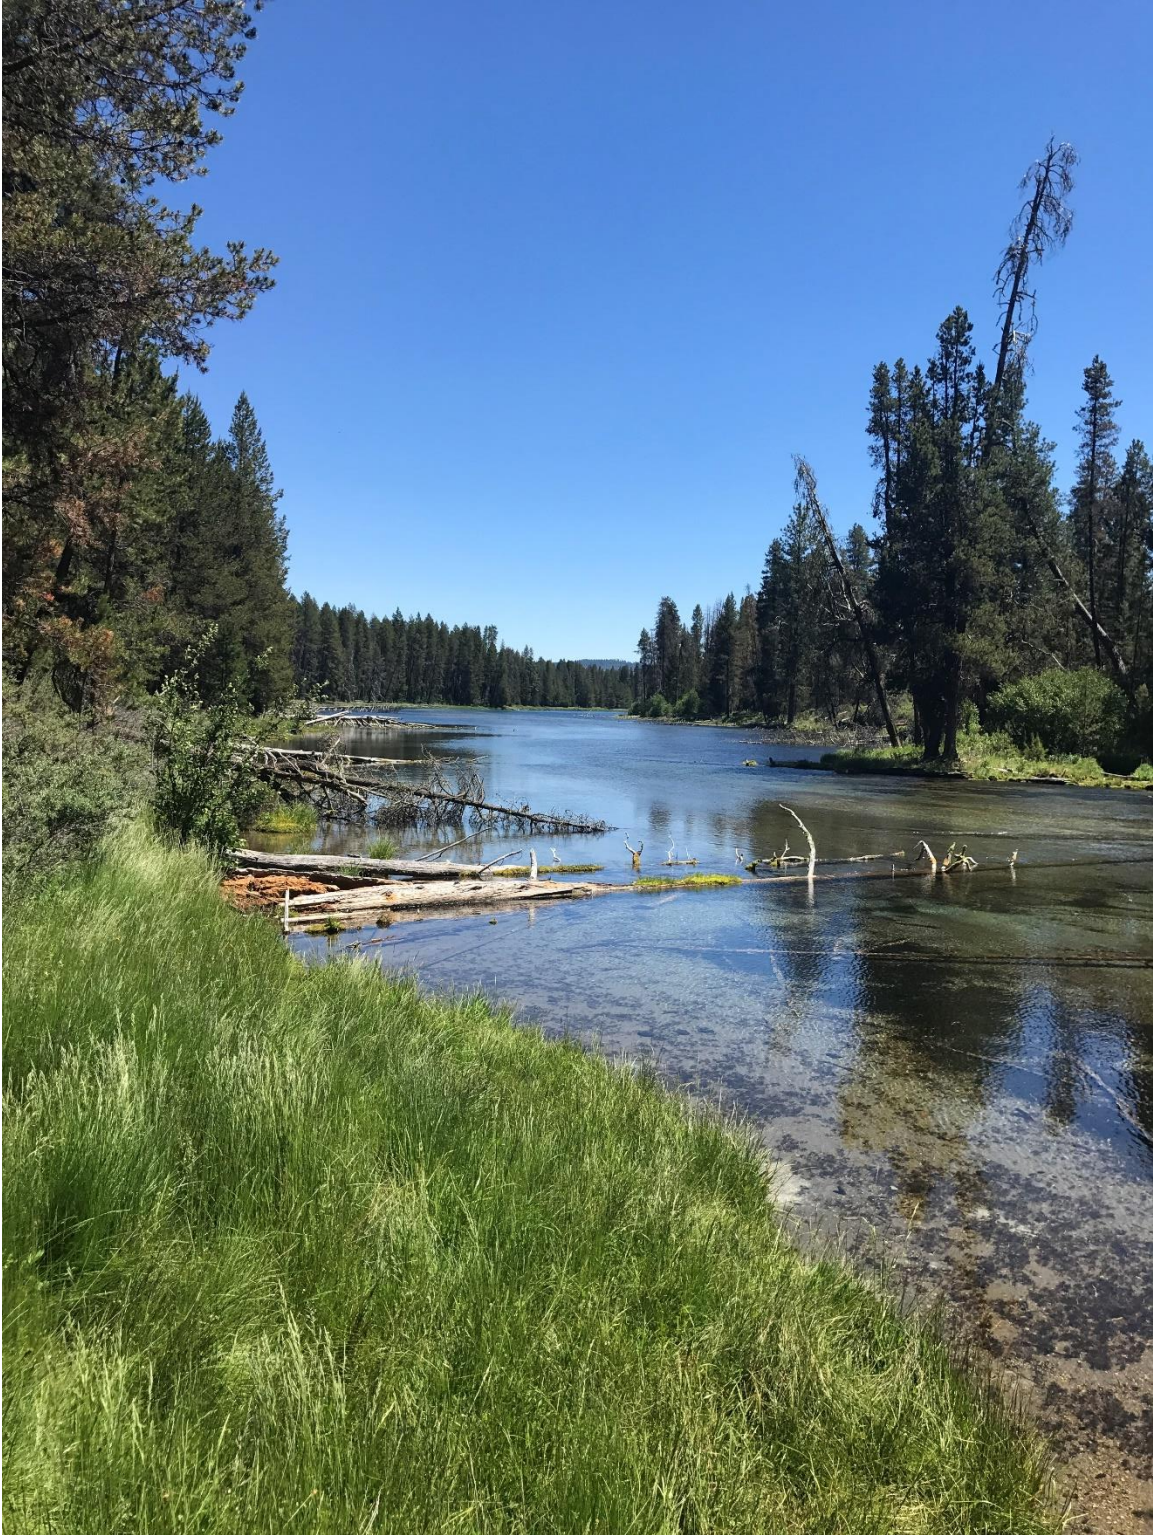
FIGURE 21: SPRING CREEK (LOOKING DOWNSTREAM) AT LOCATION WHERE A SMALL DIRT ROAD WAS MISIDENTIFIED AS A CANAL FROM ELEVATION DATA.
